# FAILURE ANALYSIS GEARS-SHAFTS-BEARINGS-SEALS

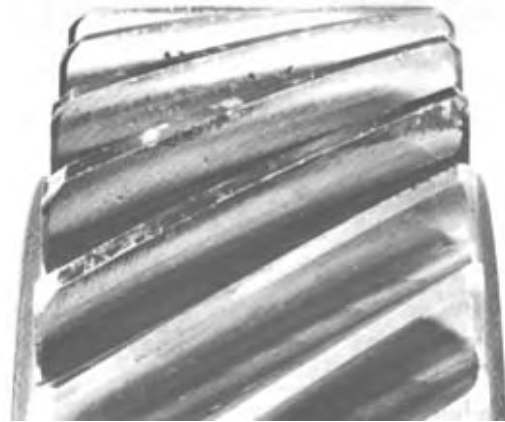
INITIAL PITTING is caused by local areas of high stress due to uneven surfaces on the gear tooth. This type pitting can develop within a relatively short time, reach a maximum and with continued service polish to a lesser severity. Initial pitting shown in **Figure 2.3** usually occurs in a narrow band at the pitchline or just slightly below the pitchline. It is most prominent with through-hardened gears and is sometimes seen with surface-hardened gears.

FIG. 2.3 (683-2) INITIAL (CORRECTIVE) PITTING

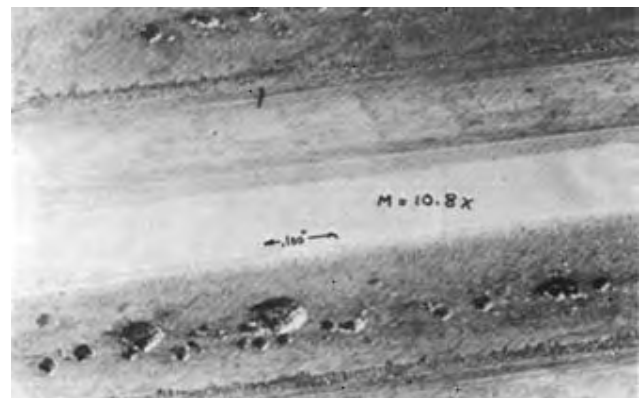
The shape of a classical pit is shown in **Figure 2.4**. It appears as an arrowhead pointing in the direction of on coming contact. Starting at the surface of the tip of the arrowhead, the fracture proceeded inward at a shallow angle to the surface. Simultaneously, the crack broadened forming the arrowhead. The back side of the pit has a steep side. The magnified pit shown in **Figure 2.4** is shown with the remaining portions of the tooth in **Figure 2.5**. Although there were several large pits on the tooth surface, this pitting was corrective since it progressed no further with continued operation.

FIG. 2.4 (683-9) INITIAL (CORRECTIVE) PITTING ENLARGED PHOTO

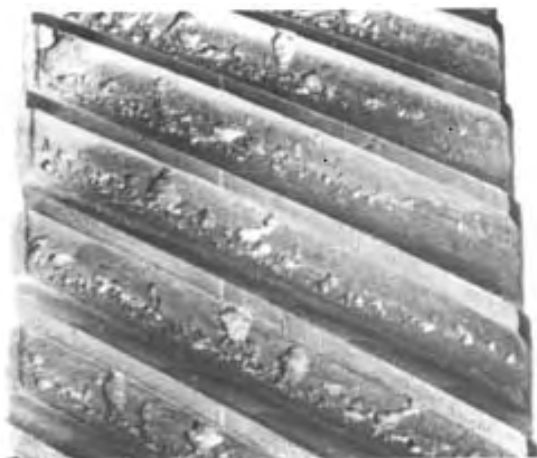
DESTRUCTIVE OR PROGRESSIVE PITTING on the other hand usually starts below the pitch line, in the dedendum portion of the tooth and progressively increases in both the size and number of pits until the surface is destroyed. Destructive pitting can appear to be as severe as corrective pitting at the beginning of operation, however, as time goes on the severity of destructive pitting sharply increases and far surpasses the severity of corrective pitting as shown in **Figure 2.6**. **Figure 2.7** illustrates this type pitting on a through-hardened gear. **Figure 2.8** shows destructive pitting of a surface hardened gear.

FIG. 2.7 (828-1) DESTRUCTIVE (PROGRESSIVE) PITTING THRU HARDENED GEARS

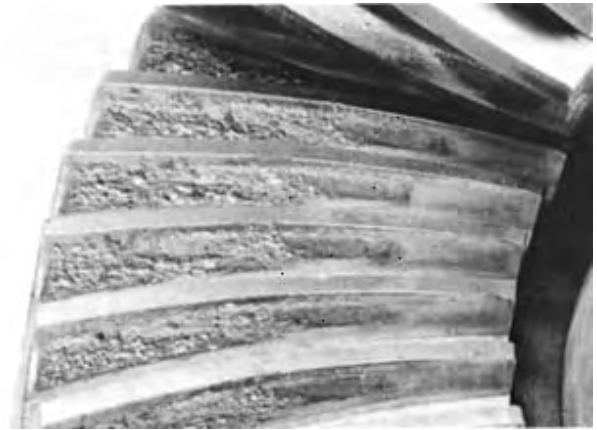
FIG. 2.8 (2342-2C) DESTRUCTIVE (PROGRESSIVE) PITTING

Destructive pitting usually results from surface overload conditions that are not alleviated by initial pitting. If tooth surface hardness is within specified values, system overloads are usually the cause of such pitting. To see a finely pitted gear, with several large pits is no cause for alarm since it can be of a corrective nature, see **Figure 2.9**.

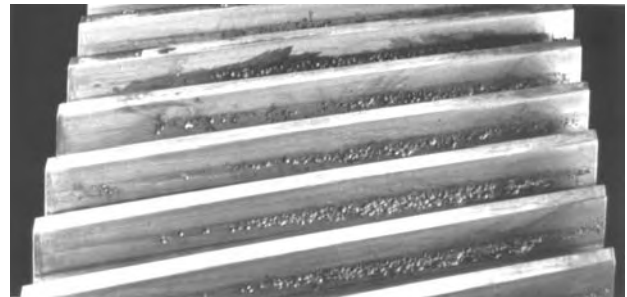
FIG. 2.10 (2342-4C) NORMAL DEDENDUM WEAR

NORMAL DEDENDUM PITTING (DEDENDUM WEAR) of fully loaded through-hardened gears manifests itself as small or modest size pits, covering the entire dedendum portion of the tooth flanks. Continued operation results in pit rims being worn away with virtually no further pitting occurring. **Figure 2.10** shows the tooth appearance in the pitting phase, prior to pit rim wear. **Figure 2.11** illustrates a dedendum pitted gear tooth after pit rims have been worn away.

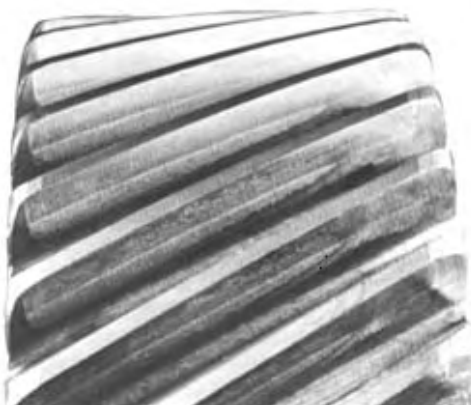
FIG. 2.13 (683-12) MICRO-PITTING (FROSTING)

MICRO-PITTING (FROSTING). **Figure 2.13** shows a micro-pitted carburized tooth as it appears to the naked eye and **Figure 2.14** shows the surface and micro-pitting enlarged 430 times. This type of pitting is considered to be normal.

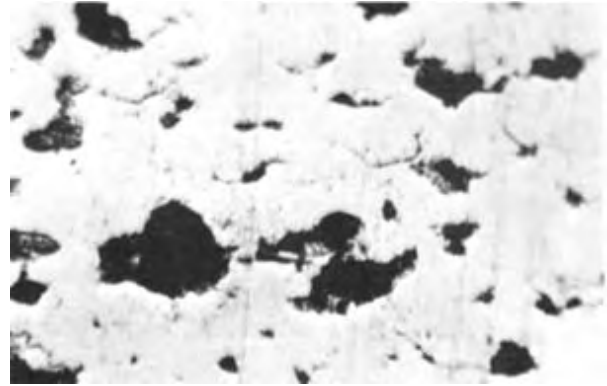
FIG. 2.14 (2342-6C) MICRO-PITTING (ENLARGED PHOTO)

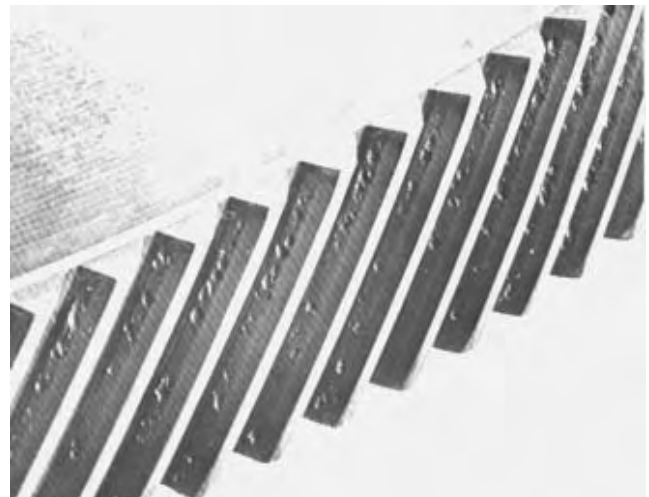
SPALLING is a term used to describe a large or massive area where surface material has broken away from the tooth. In through-hardened and softer material, it appears to be a massing of many overlapping or interconnected large pits in one locality. See **Figures 2.15** and **2.16**. In surface hardened material it manifests itself as the loss of a single or several large areas of material. The visual pit like attributes are not observed, see **Figure 2.17**. Frequently the bottom of the spall appears to run along the case-core interface.

FIG. 2.15 (13-162) SPALLING (THRU HARDENED GEAR)

Spalling is caused by high contact stresses possibly associated with proud areas of the tooth surface. With surface-hardened gear teeth, surface or subsurface defects or excessive internal stresses from improper heat treatment also can cause spalling.

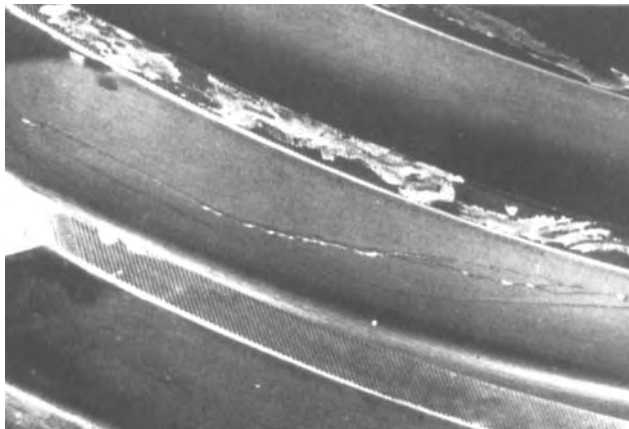
CASE CRUSHING is another form of spalling associated with heavily loaded case-hardened gears. It appears as long longitudinal cracks on the tooth surface which may subsequently break away. It often occurs suddenly, without

FIG. 2.18 (2342-8C) CASE CRUSHING

warning signs, on only one or two teeth of the pinion or gear. The cracks differ from those of pits in that they not only extend below the hard case, but most of its depth is in the softer core material. The cracks in the case, generally are perpendicular to the surface. Figure 2.18 shows an example of this failure mode. Failure may be due to insufficient case depth, insufficient core hardness or high residual stresses or too high loading.

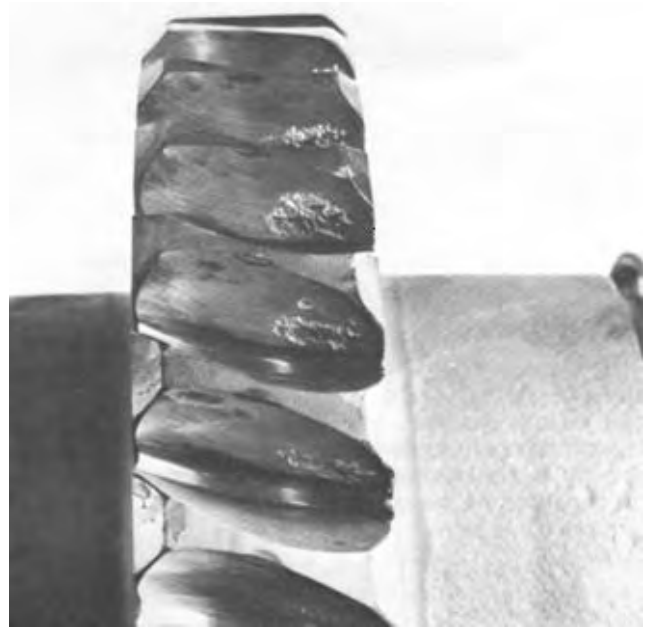
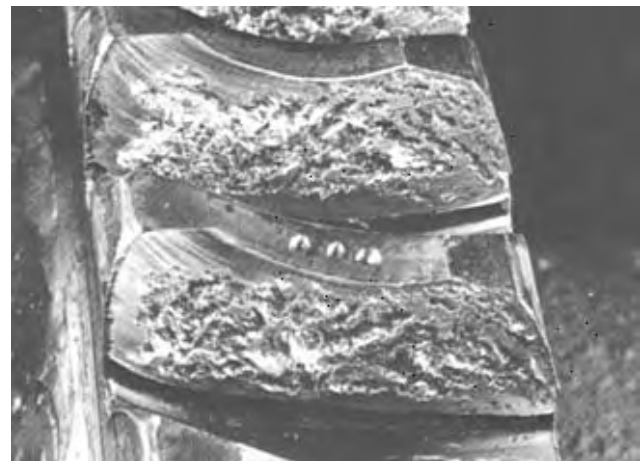
FIG. 2.19 (1169-16) WORM GEAR PITTING)

FIG. 2.20 (596-2) WORM GEAR PITTING)

WORM GEAR endurance tests have been performed by Falk during the past several years. The tests have run to approximately 20,000 hours and from these tests varying degrees of surface destruction may be severe when compared with that of a helical gear, the worm gears nevertheless survived the test. From this experience we can conclude that worm wheels incurring this amount of destruction can still perform satisfactorily. **Figures 2.19 and 2.20** illustrate this surface deterioration.

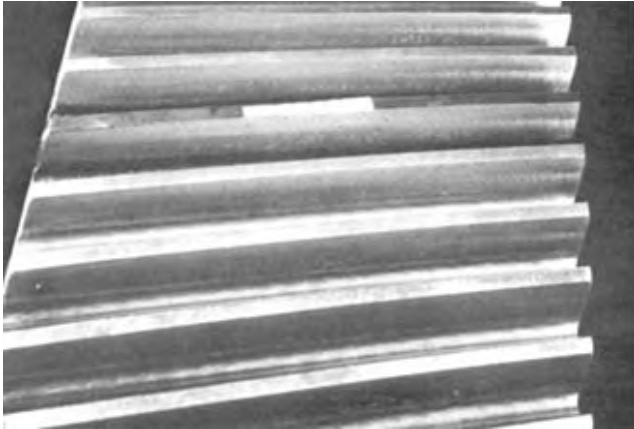
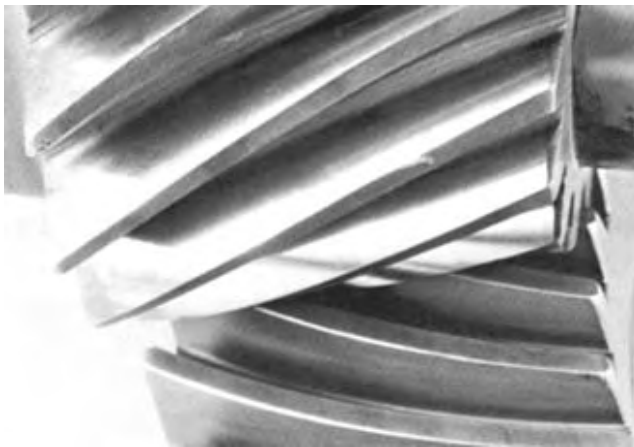
POLISHING OR LIGHT WEAR, **Figures 2.21** and **2.22** is the slow loss of metal at a rate that will little affect satisfactory performance of the gears within the life of the gears. It is a normal, very slow wear-in process in which asperities of the contacting surfaces are gradually worn until very fine, smooth, conforming surfaces develop. Polishing or light wear can occur by either abrasive or adhesive mechanisms when thin oil films or what is known as boundary lubrication conditions prevail usually on slow speed applications.

**FIG. 2.21 (697-7) INITIAL PITTING AND LIGHT WEAR**

**FIG. 2.22 (2342-9C) POLISHING (SURFACE HARDENED GEAR)**

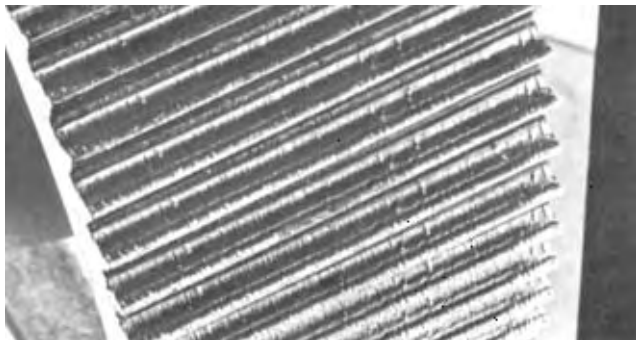
**FIG. 2.24 (747-1) EXCESSIVE WEAR**

EXCESSIVE OR DESTRUCTIVE WEAR, see **Figure 2.24**, is surface destruction that has changed the tooth shape to such an extent that smoothness of meshing action is impaired and life is appreciably shortened. Continued operation results in still greater wear and may eventually lead to tooth breakage.

The occurrence of such wear early in the operational history, can be caused by excessive loads, contaminated oil or too light an oil viscosity. Excessive wear incurred over a long period of operational history would be considered an advancement of normal wear from the moderate to the excessive degree and may not be detrimental to the operation of the gear drive.

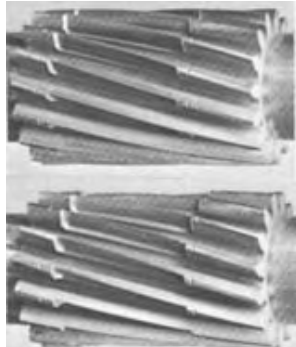
GEAR SANDBLASTED  
5 HRS.  
.025 WEAR

GEAR SANDBLASTED  
50 HRS.  
.070 WEAR

FIG. 2.26 (749-1) ABRASIVE WEAR (THRU HARDENED GEAR)

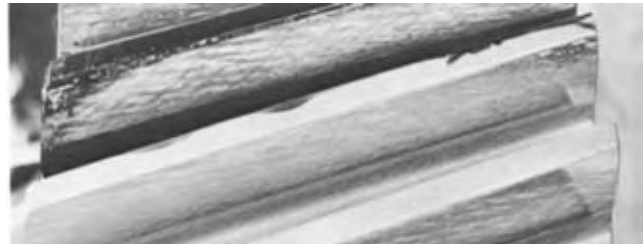
SCRATCHING is a form of abrasive wear, characterized by short scratch-like lines in the direction of sliding. This type of damage is usually light and can be stopped by removing the contaminants that caused it. **See Figure 2.27.**

FIG. 2.27 (2342-10C) SCRATCHING

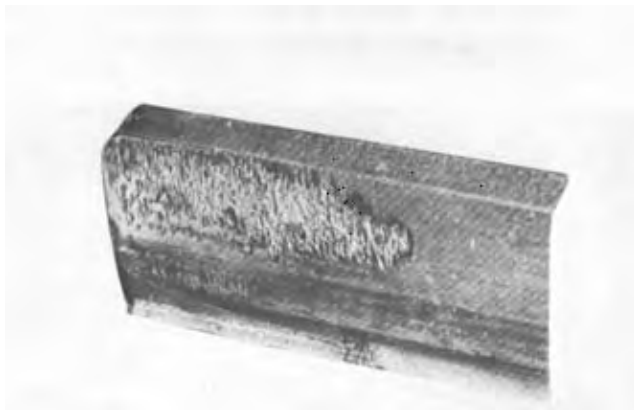
SCORING, **Figure 2.30**, is the smearing and rapid removal of material from the tooth surface resulting from the tearing out of small particles that become welded together as a result of oil film and high temperature metal-to-metal contact in the tooth mesh zone. After welding occurs, sliding forces tear the metal from the surface producing a minute cavity in one surface and a projection on the other. The wear initiates microscopically, however, it progresses rapidly.

Scoring most frequently occurs in localized areas on the tooth where high contact pressure exists or at the tip or root where sliding velocities, and hence contact temperatures, are high. This mode of wear is usually associated with high pitch line velocities and is not common in the lower hardness through-hardened gears running at normal commercial speeds.

The direct causes of scoring are high contact temperature and pressure and marginal lubrication. Scoring can sometimes be prevented by use of more viscous oil or by an EP type oil. Localize high contact pressure can be relieved by improved finishing of tooth surfaces. Sometimes profile or face modifications are required on highly loaded teeth to minimize high localized pressures.

**FIG. 2.30 (683-1) SCORING**

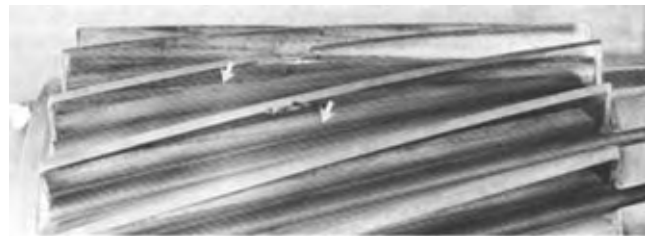
WAVY TOOTH WEAR is occasionally observed on gears. Teeth can be observed to have wavy or undulating surfaces either by light reflection or by profile and lead checks. The crests and valleys of the waves usually lie parallel to the inclined lines of helical contact. See **Figure 2.32**. This wear pattern is thought to be caused by vibratory loads occurring in the system in which the gears are operating.

**FIG. 2.32(2342-13C) WAVY TOOTH WEAR**

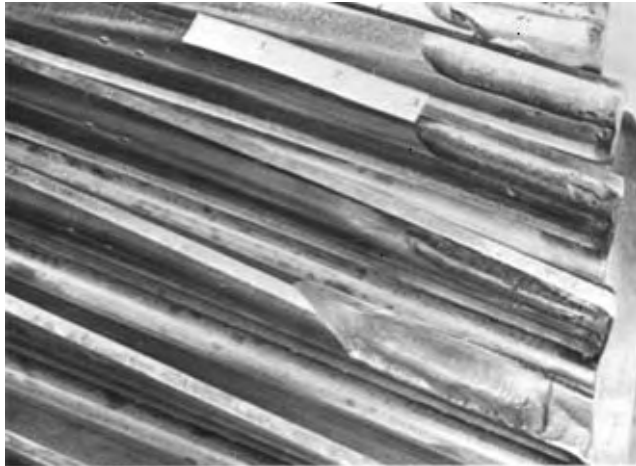
SURFACE BUMPS are occasionally experienced as shown in **Figure 2.33**. The cause of such phenomena has not yet been defined. As with welding, axial movement could cause localized high tooth pressures which could fracture teeth. The tooth surfaces should be dressed to remove proud bumps.

FIG. 2.33 (2342-14C) SURFACE BUMPS

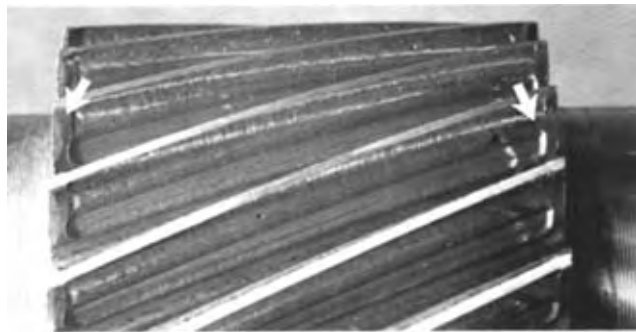
WEAR PADS. Pinion elements of a gear set are frequently made slightly wider than the gear element. As wear occurs, unworn pads are left at the tooth ends of the pinion, **Figure 2.34**. These cause no problem as long as axial positioning of gears is properly maintained. If unit is disassembled for some reason and subsequently reassembled, these pads on the ends of the pinion should be ground flush to the worn surface to assure that heavy contact, and possible tooth fracture, does not occur from this source.

FIG. 2.34 (2342-15C) WEAR PADS

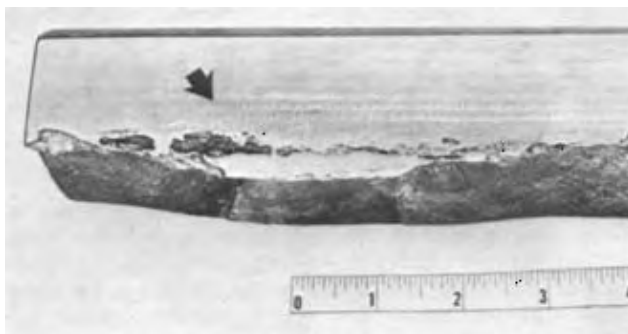
**FURROWING** has been observed on the working tooth surfaces of coarse textured, low DP, “as hobbed” mill pinion teeth shortly after being put into service. To the unaided eye, it appears as a lattice of fine hair lines oriented generally in the root-to-tip direction. They are aligned in rows across the face of the tooth in an order consistent with the hobbing texture pattern, see **Figure 2.35**.

FIG. 2.35 (2342-16C) FURROWING

The cause of furrowing has not been definitely established. Under the microscope, they appear as round bottom channels looking as if they were formed by hydraulic erosion. At present there are no recognized problems emanating from furrowing. It is thought to be prevented by minimizing localized contact pressure and by maintaining adequate lube films.

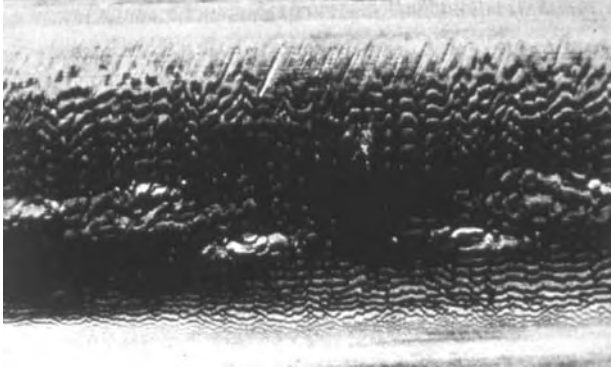
RIPPLING is a periodic wave-like formation at right angles to the direction of sliding or motion, **Figure 2.38**. It has a fish-scale appearance and is usually observed on surface hardened gear surfaces, although it can occur on softer tooth surfaces under certain conditions. Rippling is not always considered a surface failure, unless it has progressed to an advanced stage.

**FIG. 2.38 (2342-17C) RIPPLING**

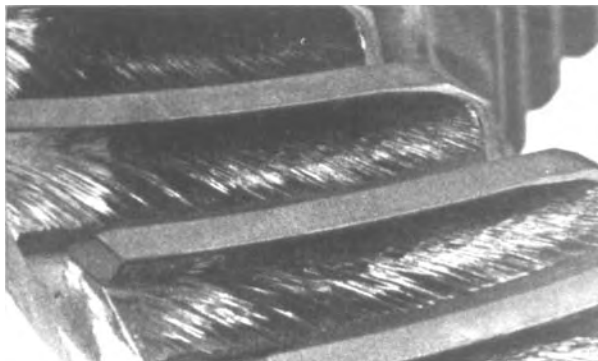
RIDGING is the formation of deep ridges by either wear or plastic flow of surface and subsurface material, **Figure 2.39**. It shows definite peaks and valleys or ridges across the tooth surface in the direction of sliding. Ridging is caused by wear or plastic flow of surface and subsurface material due to high contact compressive stresses and low sliding velocities. It is often present on heavily loaded worm and worm gear

**FIG. 2.39 (2342-18C) RIDGING**

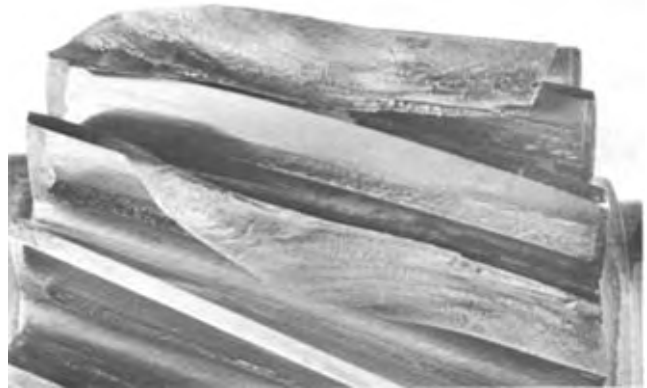
CLASSICAL TOOTH ROOT FILLET FATIGUE FRACTURE is the most common fatigue breakage mode. It is illustrated in **Figure 2.40**. The crack originates at the root fillet on the tensile side of the tooth and slowly progress to complete fracture either along or across the tooth. The face of these fractures are usually characterized by a series of contour lines or "beach marks" caused by the progressing crack "front". They indicate the position of the advancing crack front at a given time. As the section gradually weakens, the crack progresses further with each load cycle and the beach marks become more coarse. The focal point of these marks often locates the origin of the fracture.

**FIG. 2.40 (683-5) TOOTH FRACTURE (ROOT FILLET FATIGUE)**

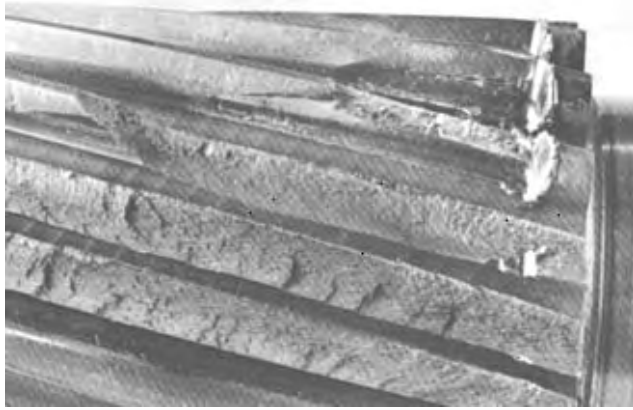
LOW CYCLE FATIGUE OR IMPACT FRACTURES are due to a low number of high load fatigue cycles or to a single very high load. **Figure 2.41** illustrates such fractures. With lower hardness, more ductile materials, the fracture face is coarse, fibrous and torn in appearance. With harder, less ductile material, the appearance may be smooth or silky looking.

FIG. 2.41 (683-7) TOOTH FRACTURE (LOW CYCLE FATIGUE)

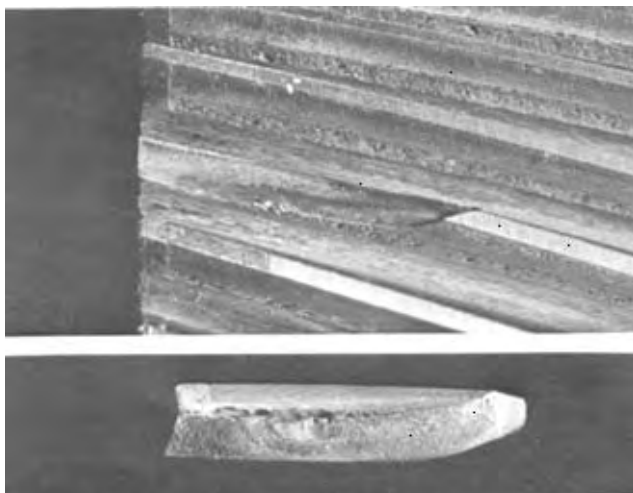
PIT ASSOCIATED FRACTURES occasionally originate in severely pitted areas since pits can act as stress raisers and can be crack origins. **Figure 2.42** illustrated such a fracture.

FIG. 2.42 (697-9) FATIGUE FRACTURE EMANATING FROM PIT

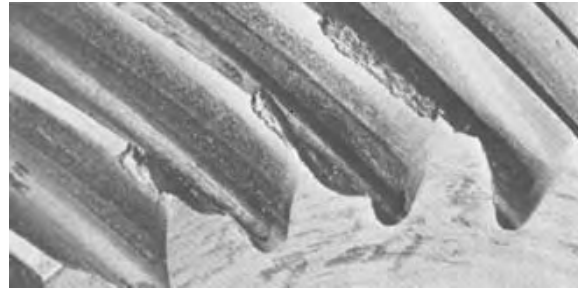
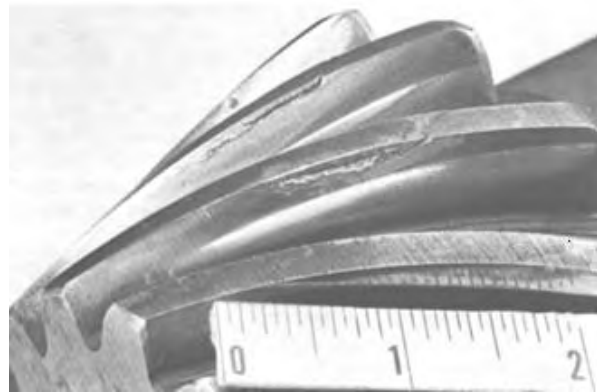
TOOTH TIP CHIPPING is a fracture mode where the top of a tooth will break away from lower portion, see **Figures 2.43 and 2.44**. Failures of this kind may be caused by deficiencies in the gear tooth, which results in a high stress concentration at a particular area. Sometimes flaws or minute grinding cracks will propagate under repeated stress cycling and a fracture will eventually develop. Foreign material passing through the gear mesh will also produce short-cycle failure of a small portion of a tooth. High residual stresses due to improper heat treatment can cause local fractures that do not originate in the tooth root section.

FIG. 2.43 (2342-19C) TIP CHIPPING (THRU HARDENED GEAR)

FIG. 2.44 (2342-20C) TIP CHIPPING (SURFACE HARDENED GEAR)

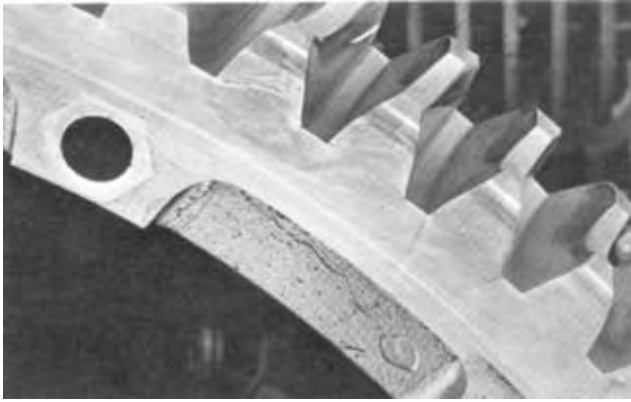
WORM WHEEL FRACTURES are occasionally encountered. **Figure 2.45** shows a tooth root fracture on a bolt-on type worm wheel. Such failures are rare and are indicative of overloading.

FIG. 2.45 (2342-21C) WORM WHEEL TOOTH FRACTURE

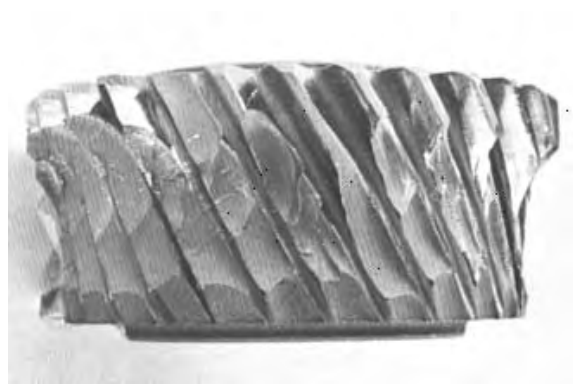
FRACTURE DUE TO FAILURE OF ASSOCIATED PARTS. Sometimes a severe load maldistribution of load on gear teeth can occur from damage to associated parts. **Figure 2.46** illustrates a pinion run for a time after a severe bearing failure. Load shifted to one end of the teeth and they subsequently broke away. The process repeated itself two more times before the element was finally removed from service. Similar fractures could occur from shaft that is severely bent or broken.

FIG. 2.46 (683-14) TOOTH FRACTURE FROM BEARING FAILURE

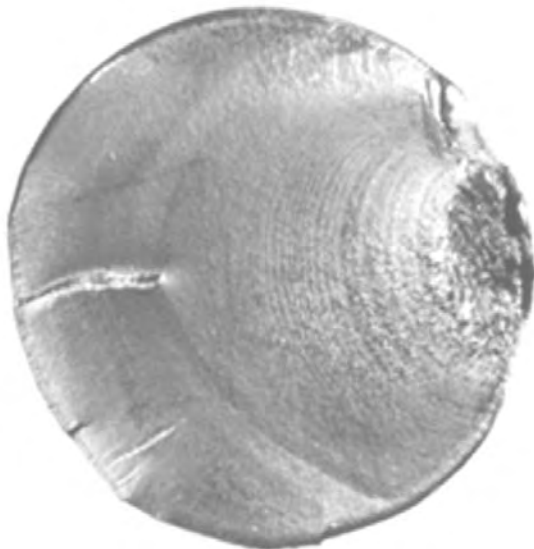
In general, fractures resulting from bending stresses are perpendicular to the shaft axis, see **Figure 3.1**, whereas fracture resulting from fatigue type torsional stresses most frequently are disposed at a 45° angle to the shaft axis, see **Figure 3.2**.

**FIG. 3.1 (2342-25C) BENDING FRACTURE**

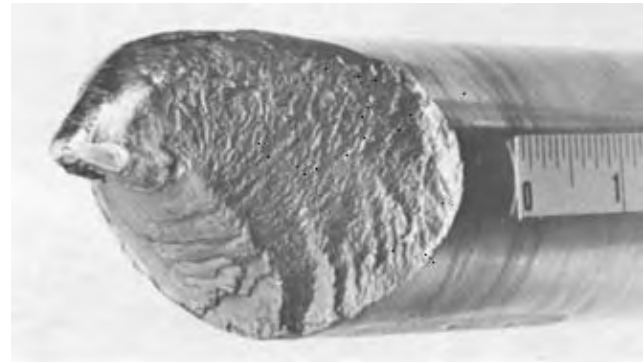
**FIG. 3.2 (2342-26C) TORSIONAL FRACTURE**

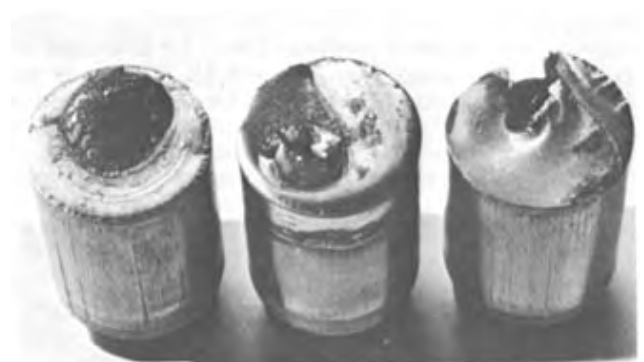
**Figure 3.3** illustrates three types of shaft fractures. The one on the left resulted from bending fatigue due to a high stress raiser at a fillet. Note the many ratchet marks around the periphery at the fillet location indicating multiple crack starts. The fracture of the center shaft was due to bending fatigue, essentially having started at one location and propagating to shaft center when final fracture occurred. The fracture of the shaft shown on the right was primarily due to torsional fatigue originating at the left of the keyway. This crack propagated in the counterclockwise direction, but final fracture, to the right of the keyway was caused by bending. The small area of the final fracture zone indicates that the nominal stress was low.

**FIG. 3.3 (548-7) SHAFT FRACTURES**

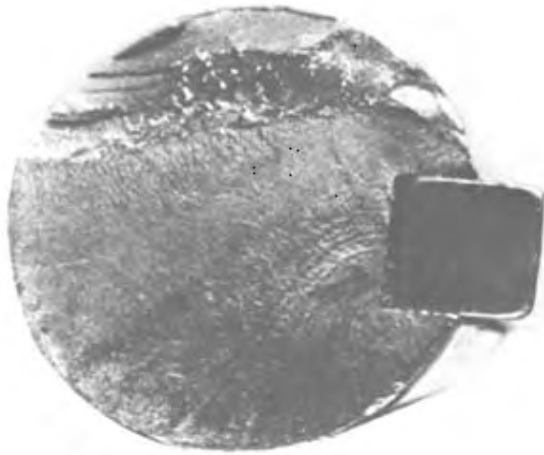
**KEYS AND KEYWAYS.** Some fatigue fractures start from a combination of stress raisers such as a keyway and the end of a key. **Figure 3.4** shows such a failure. The strength of a keyed joint is affected by the distribution of the load along the keyway. The strength of the shaft at the keyway depends on position of the key in the hub, the accuracy of the key and the keyway, the geometric shape of the end of the keyway and the location relative to shaft shoulder fillets and the magnitude of the interference fit.

**FIG. 3.4 (548-1) SHAFT FRACTURE (KEY AND KEYWAY ASSOCIATED)**

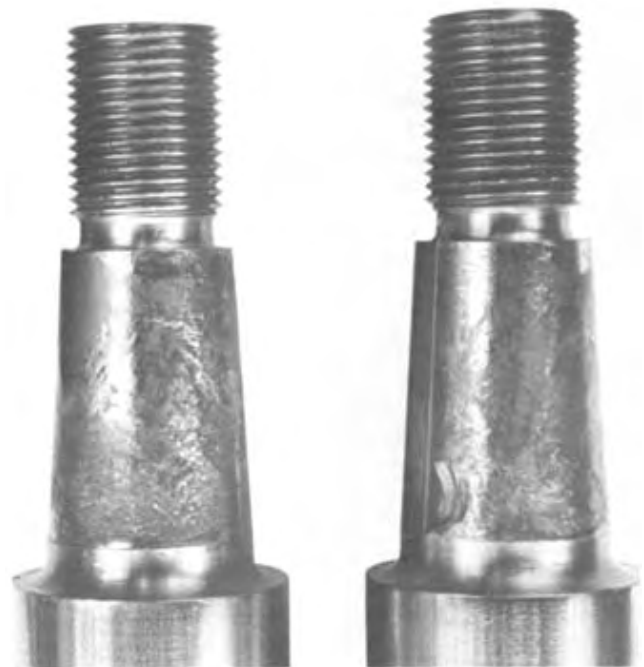
**FRETTING CORROSION** occurs where minute relative movement of tightly fitted parts occurs such as at bearing, gear and coupling hub seats. As fretting progresses, minute cracks form at the surface of the shaft which form stress raisers which can become origins for fatigue cracks. **Figure 3.7** illustrates such a situation. Fits must be designed properly and manufactured accurately to assure proper fit pressure to prevent fretting. On taper bore fits, locknuts which hold the gear in place must be properly torqued.

**FIG. 3.7 (2342-27C) FRETTING CORROSION**
