# FAILURE ANALYSIS GEARS-SHAFTS-BEARINGS-SEALS

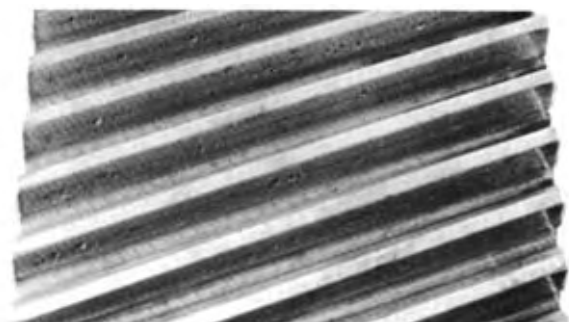
For most through-hardened industrial type gears, initial pitting is considered normal and no remedial action is required. Where necessary, initial pitting can be reduced by special tooth finishing means and sometime by a careful break-in at reduced loads and speeds. In some special critical applications, teeth are copper or silver plated to prevent or reduce initial pitting.

FIG. 2.5 (697-4) INITIAL (CORRECTIVE) PITTING

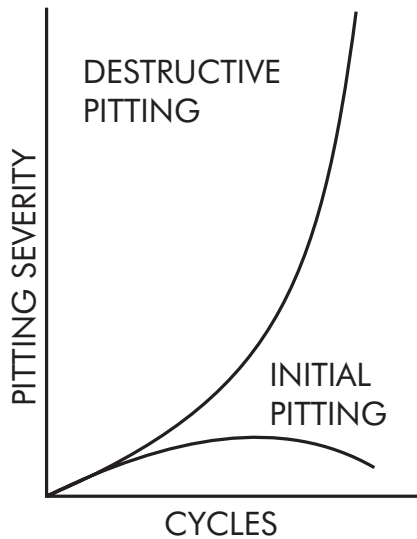
FIG. 2.6 (2342-1C) PITTING SEVERITY

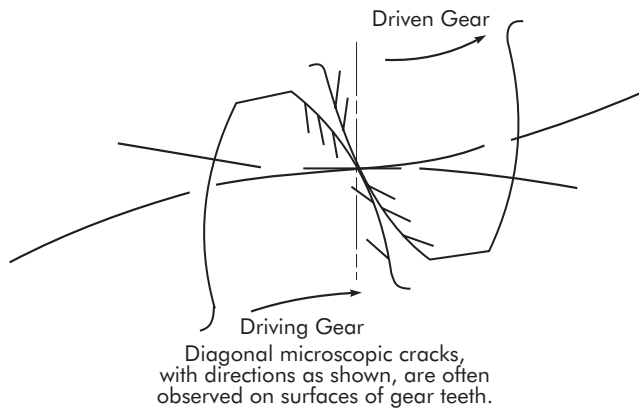
Dedendum pitting results when loads are at or close to maximum allowable surface loading values. The dedendums are most vulnerable to this phenomenon because of the preferential orientation of the surface microcracks along the tooth profile. **Figure 2.12** illustrates this. The orientation of the cracks in the dedendum of both pinion and gear are such that oil is

readily trapped in them as the contact rolls over the surface openings. These then propagate rapidly into pits by hydraulic pressure. In the addendum, the oil is forced out of the microcracks before the contact progresses far enough to seal the surface openings off, hence hydraulic propagations of the crack is almost nil and few pits are formed in this region.

FIG. 2.12 (2342-5C) TOOTH SURFACE MICROCRACKS

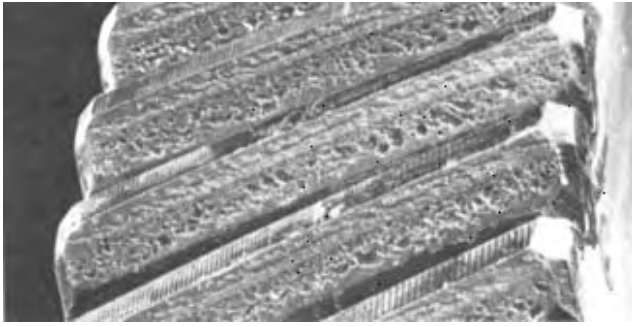
SPALLING is a term used to describe a large or massive area where surface material has broken away from the tooth. In through-hardened and softer material, it appears to be a massing of many overlapping or interconnected large pits in one locality. See **Figures 2.15** and **2.16**. In surface hardened material it manifests itself as the loss of a single or several large areas of material. The visual pit like attributes are not observed, see **Figure 2.17**. Frequently the bottom of the spall appears to run along the case-core interface.

Spalling is caused by high contact stresses possibly associated with proud areas of the tooth surface. With surface-hardened gear teeth, surface or subsurface defects or excessive internal stresses from improper heat treatment also can cause spalling.

FIG. 2.16 (2342-7C) SPALLING (THRU HARDENED GEAR)

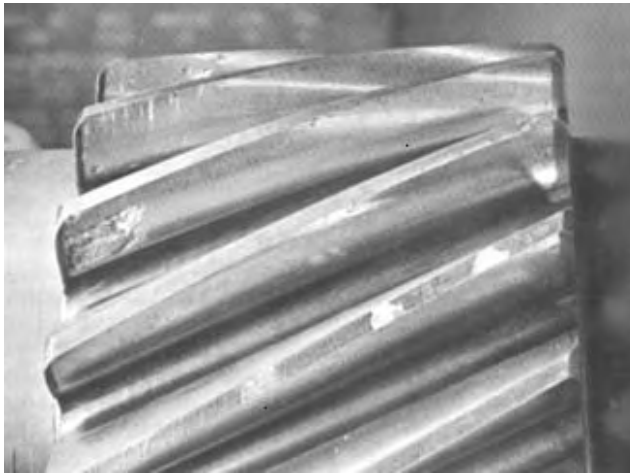
FIG. 2.17 (828-2) SPALLING (SURFACE HARDENED GEAR)

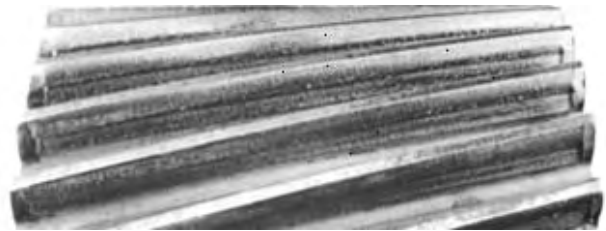
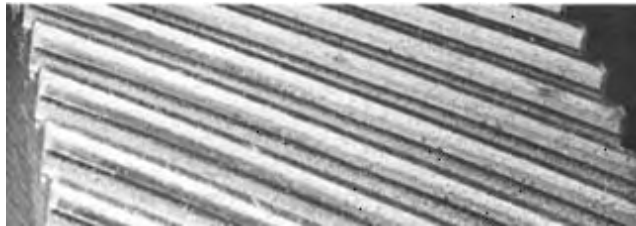
**Figure 2.23** illustrate wear observed on gears early in their operational history. Subsequently, these gears continued in operation to give years of additional satisfactory service.

**FIG. 2.23 (697-10) TYPICAL TOOTH SURFACE APPEARANCE**

Moderate wear is normal and usually no remedial action is required other than normal maintenance of the lube system. If contaminants are present, filtering or more frequent lube changes are appropriate.

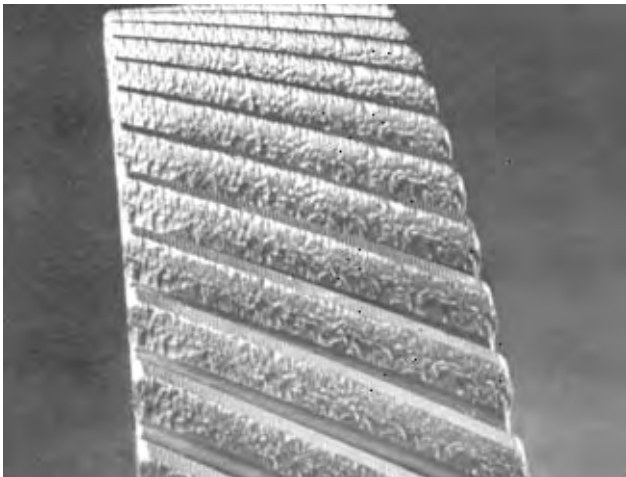
ABRASIVE WEAR, sometimes called cutting wear occurs when hard particles slide and roll under pressure, across the tooth surface. Hard particle sources are: dirt in the housing, sand or scale from castings, metal wear particles from gear teeth or bearings, particles introduced into housing when filling with lube oil and particles infiltrating into unit in service. **Figure 2.25** shows abrasive wear of a through-hardened gear caused by massive loss of hard surface material from tapered bearing surfaces. Gear teeth surfaces hardened after cutting sometimes have rough surface that may wear softer mating teeth. **Figure 2.26** shows through hardened teeth that were worn away in just a few hours from the flame-hardened teeth which had rough surfaces due to a sand blast cleaning operation.

FIG. 2.25 (942-3) ABRASIVE WEAR (THRU HARDENED GEAR)

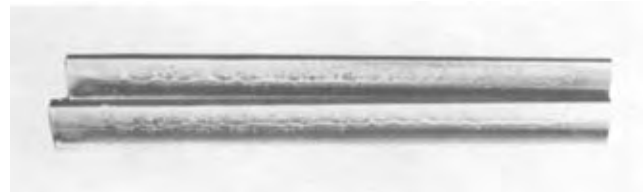
Adhesive wear depends upon the bond strength, which relates to the physical chemistry of the contact material and lubricant, on the load and on the material hardness. **Figures 2.28 and 2.29** show typical surfaces of through hardened and surface-hardened gears respectively that have undergone adhesive wear.

FIG. 2.28 (2342-11C) ADHESIVE WEAR (THRU HARDENED GEAR)

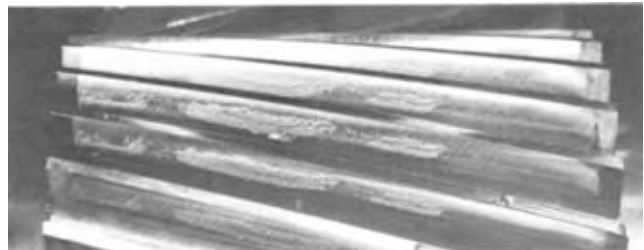
FIG. 2.29 (2342-12C) ADHESIVE WEAR (SURFACE HARDENED GEAR)

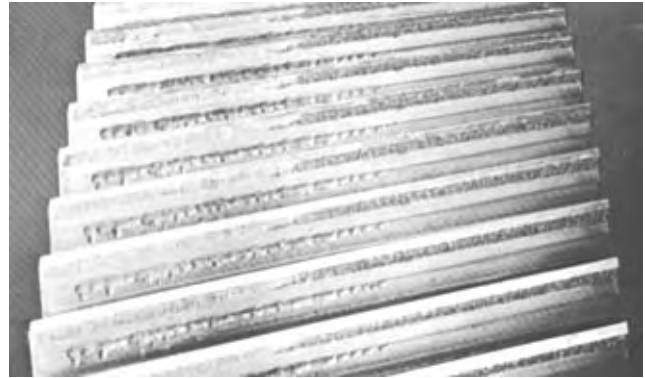
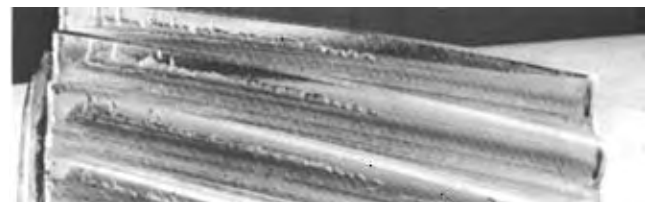
WELDING is a hybrid form of scoring and pitting, where pit cracks are formed on the gear member with pit bodies subsequently adhering or welding to the pinion member. The two then run together with the profile formed by the original involute and the resultant pits bodies and pit cavities, see **Figure 2.31**. This phenomena is thought to occur at high load low speed and at marginal lubrication condition where high contact temperature prevail, but classical scoring doesn't occur. Increased oil viscosities or EP lubricants may help. Reduced loads will aid. Care must be exercised that axial displacement of the mating pinion and gear does not occur as high localized pressure can result from the mismatching of high and low profile spots which could cause fracture. If gearing is disassembled and reassembled, the tooth surfaces should be dressed to remove proud bumps.

**FIG. 2.31 (683-13) WELDING (METAL TRANSFER GEAR TO PINION)**

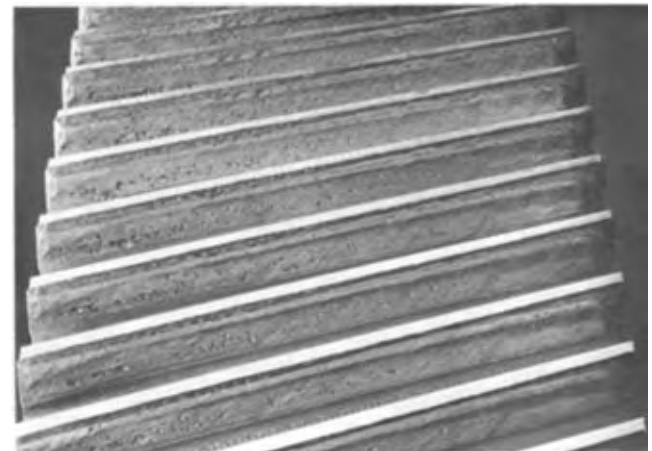
**COLD FLOW** occurs when the surface and subsurface material show evidence of metal flow. Often surface material has been worked over the tips and ends of the gear teeth, giving a finned appearance. See **Figure 2.36**. This is sometimes called **ROLLING** or **WIRE EDGING**. Sometimes the tooth tips are heavily rounded-over and a depression appears on the contacting tooth surface. **PEENING**, another form of plastic flow as shown in **Figure 2.37**, is caused by excessive loading due to impact loading.

FIG. 2.37 (683-11) PLASTIC FLOW (PEENING)

Under heavy load, the rolling and peening action of the mesh cold-works the surface and subsurface material. The sliding action tends to push or pull the material in the direction of sliding, if the contact stresses are high enough. The dents and battered appearance of the surface are a result of dynamic loading due to operation while the profile is in the process of deteriorating from a combination of cold-working and wear. Failures of this type can be eliminated by reducing the contact stress and by increasing the hardness of the contacting surface and subsurface material. Increasing the accuracy of tooth-to-tooth spacing and reducing profile deviations will give better tooth action and reduce dynamic loads. If the high-

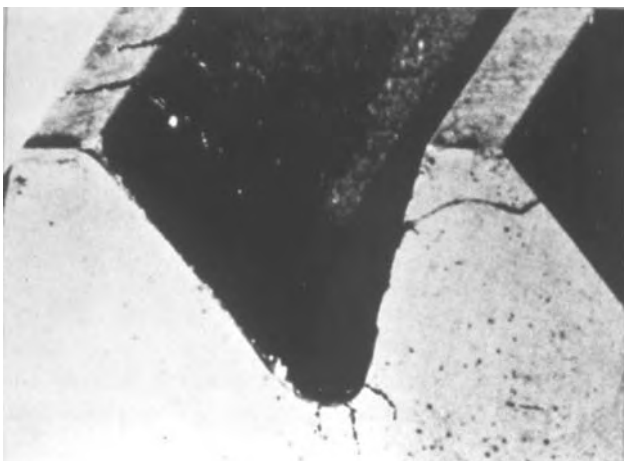
QUENCHING CRACKS can develop with some materials during heat treatment and after quenching of the gear blank in a quenching medium. Often these cracks are visible to the naked eye, **Figure 2.47**. They may run across the top land of the tooth or be radial in direction at the ends of the teeth. When these are found, the material and heat treat specifications should be reviewed and the processing procedures reexamined.

FIG. 2.47 (2342-22C) QUENCH CRACKS (THRU HARDENED MATERIAL)

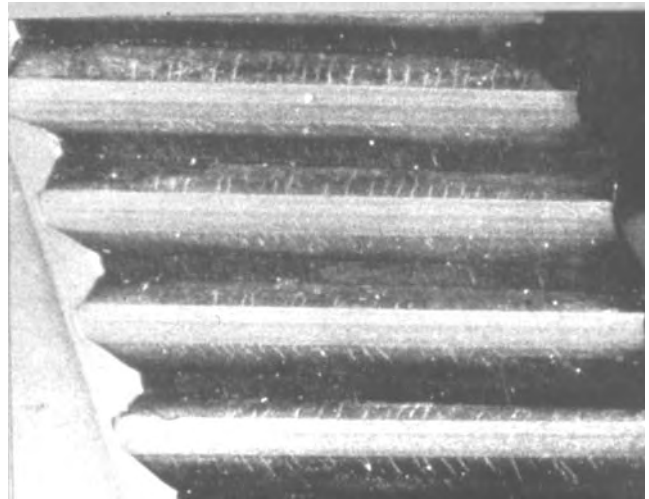
GRINDING CRACKS may form on the gear tooth surfaces due to process grinding, **Figures 2.48 and 2.49**. These surface cracks are usually in a definite pattern or network and often have the appearance of a series of short cracks laying parallel to each other. Grinding cracks may also have the appearance of a chicken wire mesh. The cause may be excessive grinding pressures or may be a metallurgical structure which is prone to cracking.

FIG. 2.48 (2342-23C) GRINDING CRACKS (ENLARGED)

When found an examination of the processing procedures is in order.

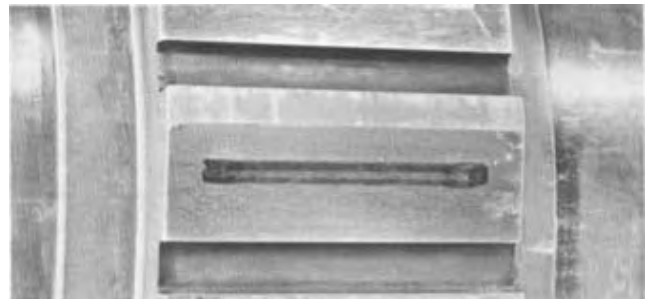
FIG. 2.49 (2342-24C) GRINDING CRACKS

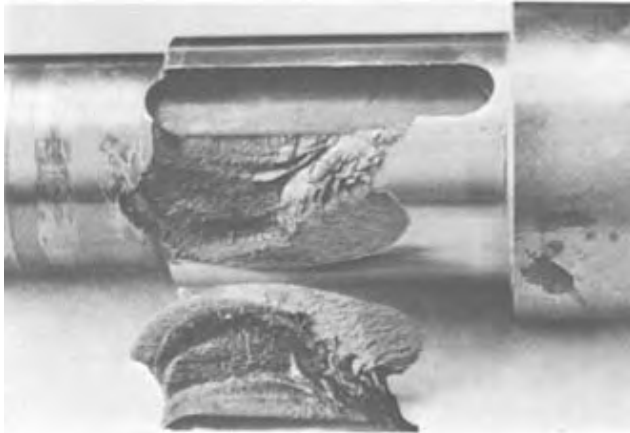
**FIG. 3.5 (548-6) SHAFT FAILURE (PEELING)**

A keyway fracture can be normal to the shaft axis as shown in **Figure 3.4** or it can peel circumferentially as shown in **Figure 3.5**. This latter type fracture occurs in a loosely fitted joint where nearly all the torque is transmitted through the key. Fatigue starts in the bottom of the keyway and progresses around the shaft axis.

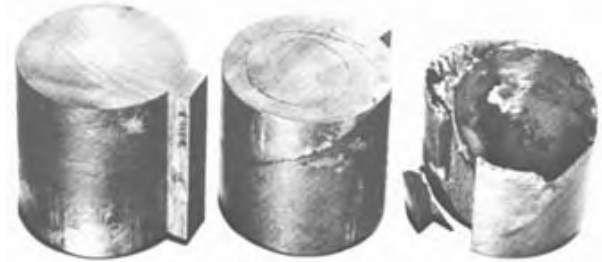
**Figure 3.6** shows a torsional fatigue failure originating at the keyway and progressing as a result of a reversing torque in the system due to dynamic effects. The final fracture zone is typical of a torsional failure occurring along a plane approximately 45° to the axis of the shaft.

**FIG. 3.6 (548-5) SHAFT FRACTURES**

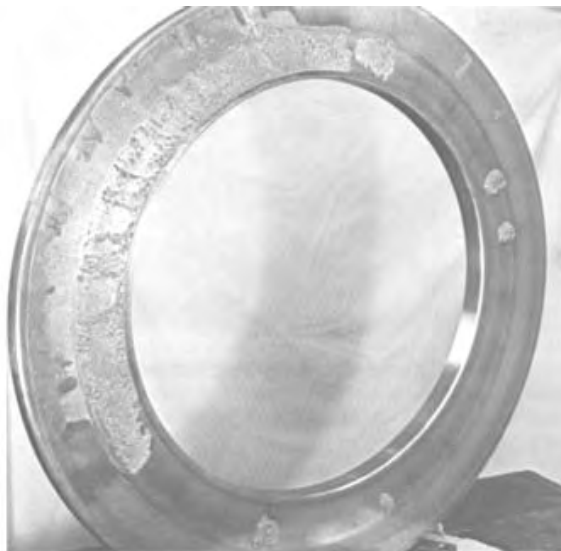
A bearing can be failed before it is placed into service, if the unit in which it is mounted is improperly stored prior to installation. The damage done to a bearing due to corrosion manifests itself by a surface that appears to be stained. Under magnification, this area contains a series of pits which serve as a nucleus for a spall which leads to a complete failure shortly after the unit is placed in service. **Figure 4.1** which is the race of a large thrust bearing illustrates this type of failure. If a spalled bearing race is not excessively damaged, it is possible to get a clue as to whether corrosion was the basic cause by noting if the spalled areas are spaced approximately the same as the roller spacing. In **Figure 4.1** note the definition of the roller spacing.

FIG. 4.1 (2342-28C) FAILURE INDUCED BY CORROSION

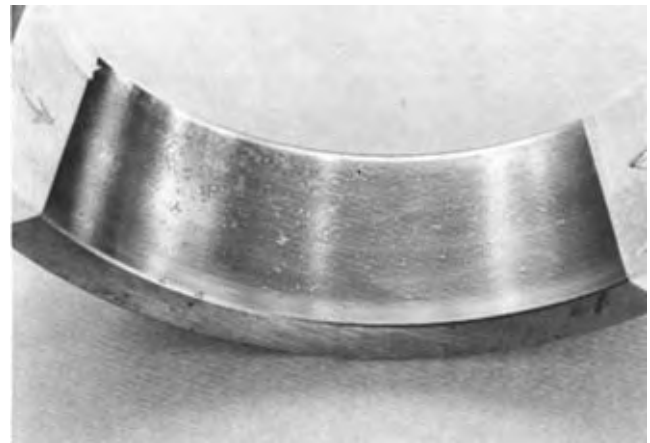
become a stress raiser from which a pit will be formed. See **Figure 4.2**.

The presence of water in the lubricant is not uncommon. The oil companies indicate that most industrial oils will contain dissolved water in the range of 50 to 500 parts per million (ppm). Research data indicates that water accelerated fatigue takes place when water concentration exceeds 100 ppm which can reduce bearing life from 30 to 80%. (6) (7)

FIG. 4.2 (2342-29C) DEBRIS DENTING

The effects of contaminants can be minimized by either preventing the ingress of the contaminant, or by changing oil at the recommended change intervals.

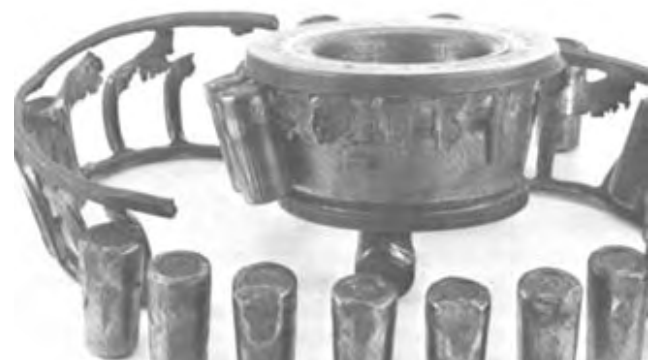
Periodically, on start up, bearings have been reported to run hot. The overheating can be caused by insufficient internal clearance or insufficient lubrication. Insufficient clearance is usually the cause. There have been instances where the thermal expansion of the bearing elements is greater than the internal clearances and the bearings will load themselves and the heat will become intense enough to weld the rollers to the races as shown in **Figure 4.3**.

FIG. 4.3 (2342-30C) WELDING OF ROLLERS

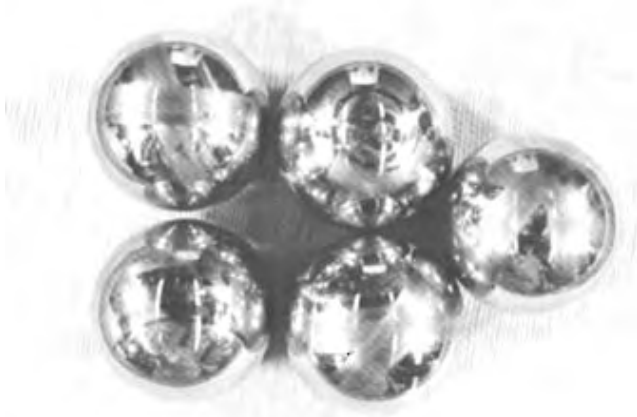
If a ball bearing has run for a period of time with insufficient internal clearance, there could be a wear band or a series of bands on the ball as shown in **Figure 4.4**.

**FIG. 4.4 (2342-31 C) BALL BANDING**

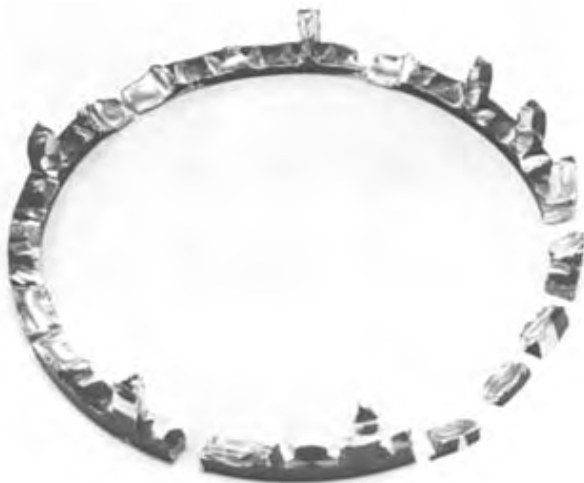
Bearing cages guide the rollers or balls in a bearing. They are usually lightly loaded. However, when a bearing is severely misaligned or when it is subjected to a vibratory load, or when the bearing is lightly loaded, the cage can be heavily loaded. The loads are caused by either the impact forces between the cage and the rollers, or the forces generated when the balls or rollers attempt to move out of their prescribed position. Lightly loaded rollers tend to skew and assume a position approximately 90° to their operating position.

These loads can cause the cage to break as shown in **Figure 4.5**. If there are stress raisers present either from the processing of the cage or from the geometry of the part, the cage will break at these stress raisers. **Figure 4.6** illustrates the effect that a notch and a reduced section can have on the cage strength and **Figure 4.7** illustrates the cracks present at a sharp edge that was not removed after machining. In either case the result is the same, a failed bearing.

**FIG. 4.5 (2342-32C) CAGE BREAKAGE**

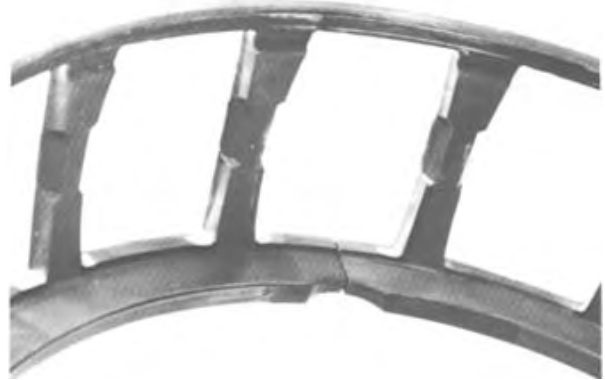
**FIG. 4.6 (2342-33C) CAGE BREAKAGE AT NOTCH AND REDUCED SECTION**

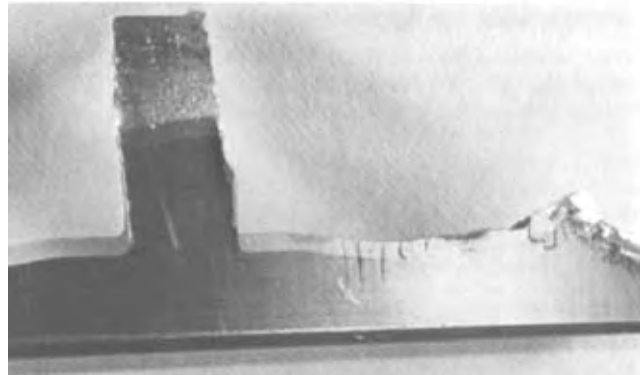
**FIG. 4.7 (2342-34C) CRACKS IN CAGE FROM NOT REMOVING SHARP EDGE**

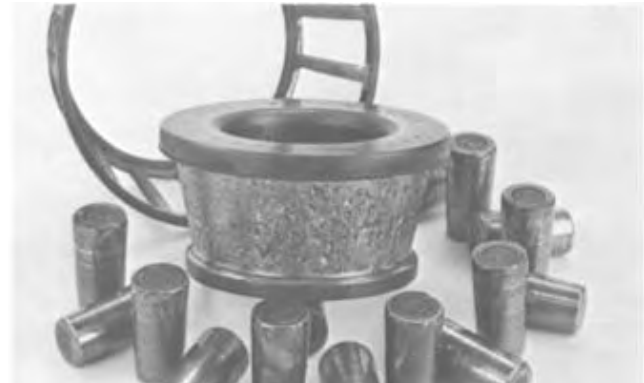
**FIG. 4.8 (2342-35C) CAGE WEAR AND ROLLER END WEAR**

Inadequate lubrication is defined today as either a lack of lubricant or the inability of the bearing to form an adequate film thickness. Lubrication damage is characterized by damaged roller ends and cages. The damage usually manifests itself as cage wear and wear on the roller ends. See **Figure 4.8**.

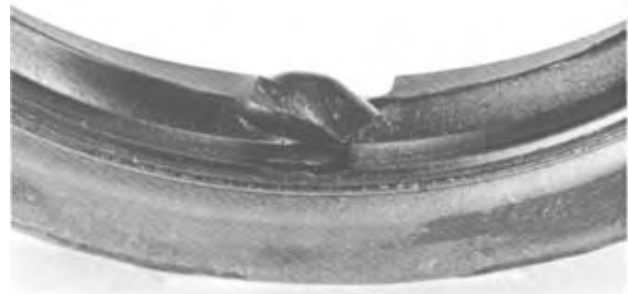
**CUT SEAL LIP.** In the handling and in the mounting of a contact seal, it is very possible to cut or nick the seal lip as it is slipped over a burr, keyway or spline. The use of proper mounting tools as defined by the seal manufacturer will prevent a cut lip. When a lip is cut, leakage is detected within several minutes after startup. A typical cut lip is shown in **Figure 5.2**.

FIG. 5.2 (2342-37C) CUT AND TURNED UNDER LIP

**TURNED-UNDER LIP.** In mounting a seal, the lip may turn under due to either an improperly designed or manufactured lead chamfer. The use of proper mounting tools and procedures will minimize the occurrence of a turned-under lip. **See Figure 5.2.**

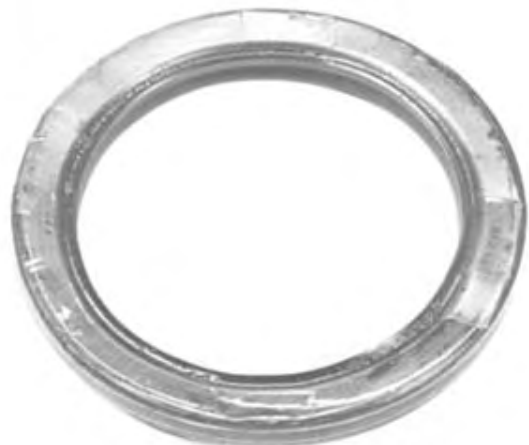
**DAMAGED OR DISTORTED SEAL CASE.** A damaged seal case as shown in **Figure 5.3** can be encountered due to careless handling and mounting. Using care and the proper mounting tool will prevent this from occurring. A distorted seal case can be caused by a seal outside diameter too large for the bore.

FIG. 5.3 (2342-38C) DAMAGED SEAL CASE

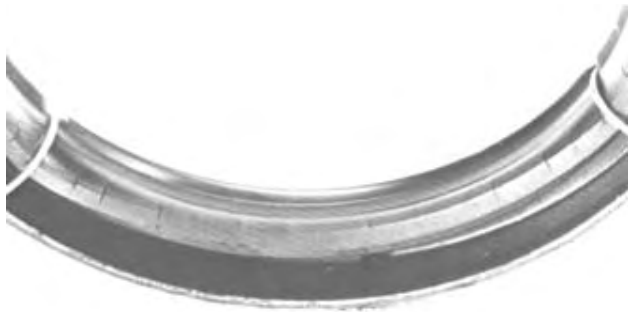
**HARDENING AND CRACKING OF THE SEAL LIP.** Elastomers harden, crack and chip at the lip-shaft interface due to excessive heat, exposure to certain extreme pressure lubricants or exposure to chemicals. The cracking is shown in **Figure 5.4**. Chipping is shown in **Figure 5.5**. Laboratory tests have indicated that a Nitrile seal (most commonly used in a Falk drive) heated to 320° F will harden to the consistency of a phonograph record within 15 minutes. Another failure mode associated with heat is the formation of blisters on the sealing lip as shown in **Figure 5.6**.

**FIG. 5.4 (2342-39C) HEAT CRACKING**

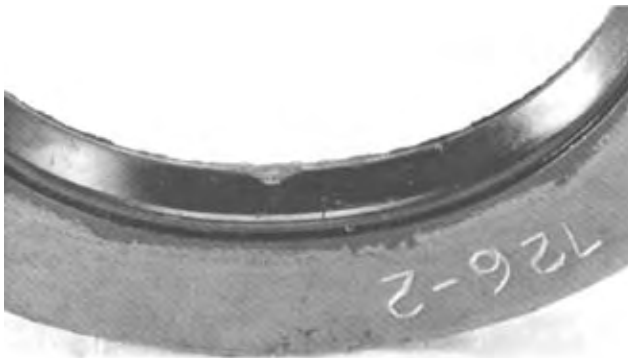
**FIG. 5.5 (2342-40C) CHIPPING OF SEAL LIP**

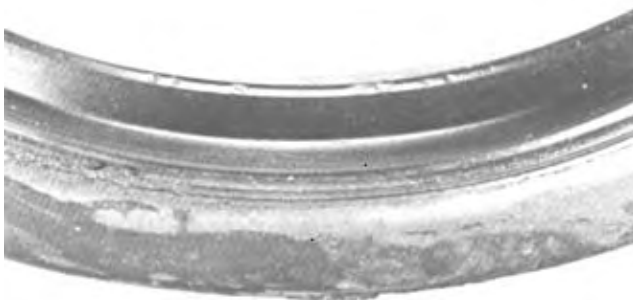
**FIG. 5.6 (2342-41C) BLISTERS ON SEAL LIP**

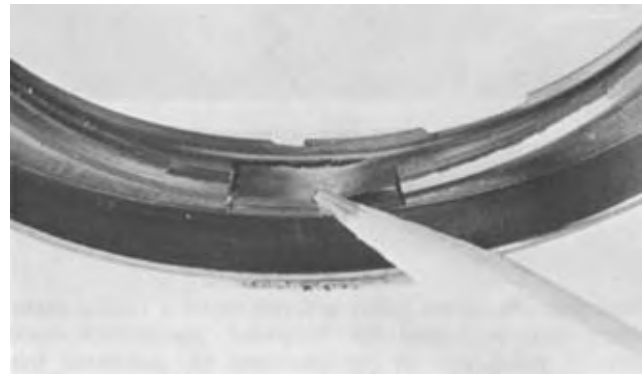
**ELEMENT CRACKING-NO HARDENING.** Tests conducted by Falk indicate that when Nitrile seals are exposed to an atmosphere of 9-11 parts per million (ppm) of ozone, they will exhibit radial and circumferential cracks without any evidence of hardening. These cracks are shown in **Figure 5.7**. When an atmosphere containing this amount of ozone is encountered, either the seal should be protected by another media such as grease, or the seal material should be changed.

**FIG. 5.7 (2342-42C) RADIAL AND CIRCUMFERENTIAL CRACKS DUE TO OZONE**

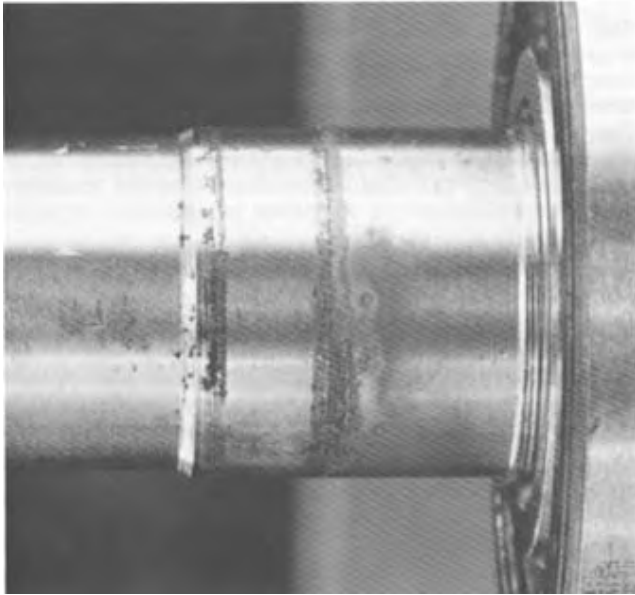
The width of the seal path on a shaft should vary from .010" to .030" and be only a few thousandths deep. See

**Figure 5.8.** If the wear path is wider than .030" or deeper than what you can feel with your fingernail, leakage may be encountered. The causes of this condition can be abrasive conditions, eccentricity between seal and shaft, cocked seal or axial motion between seal and shaft. A shaft surface with this degree of wear will leak, hence should be resurfaced or the seal should be relocated along the shaft in order to provide a new shaft surface.

FIG. 5.8 (2342-43C) JOURNAL WEAR
